Emergency Tsunami Reconstruction Project in Tamil Nadu, India

Overview

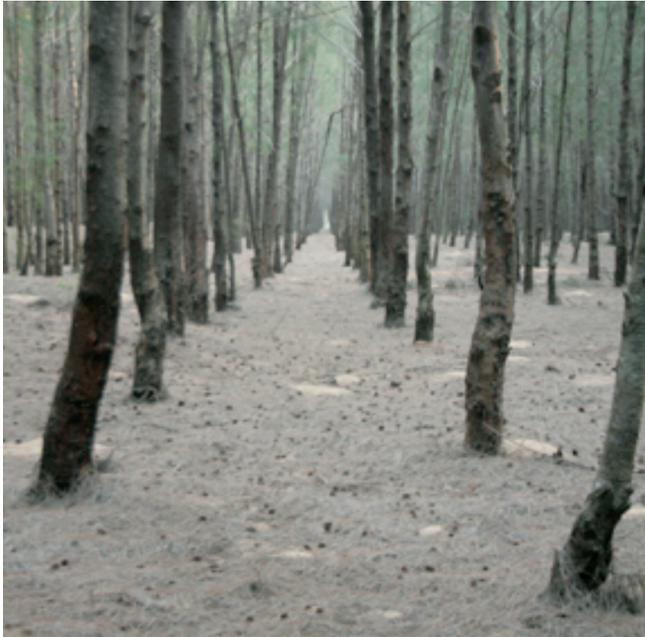
Coastal shelter belt in Allawandar Trust lands in Kancheepuram district where *Casuarina equisetifolia* is planted in neat rows at fixed intervals parallel to the shore. The *Casuarina* trees have reached a height and girth that makes them useful as scaffolding in construction sites. Each pole would yield Rs 150 and the branches would serve as fuel wood. This brings them under pressure for cutting by local population.

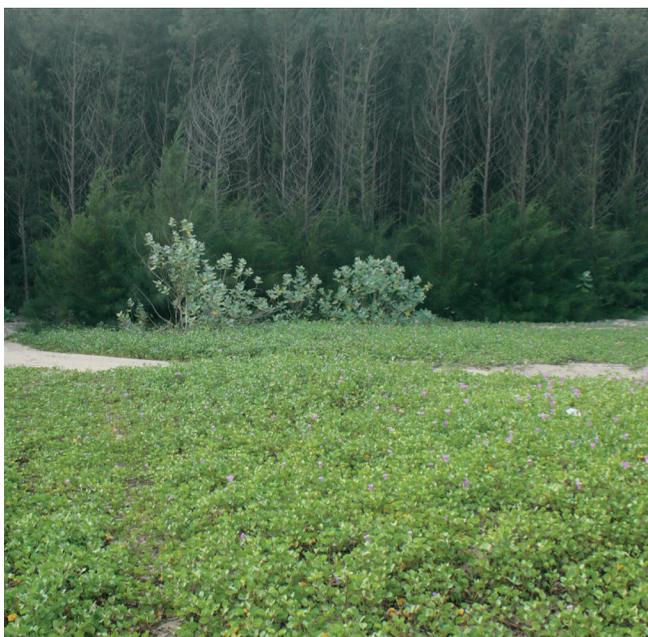
The shelterbelt as seen from the high tide line with *Ipomea biloba* in the foreground. *Casuarina* was removed to facilitate movement and nesting of Olive Ridley Turtles, and native vegetation like *Ipomea* has taken over. *Ipomea* is a runner species that also acts as a binder, holding together sand dunes and the sands above the HTL.

The shelterbelt plantations were taken up to the High Tide Line (HTL), but it was later realized that Olive Ridley Sea Turtles nest in a zone beyond the HTL. This was brought to the attention of the authorities as these plantations would affect the turtles' movement and nesting. After due review, the government sanctioned the removal of casuarinas sufficiently away from the HTL to ensure turtle nesting and free movement. The Society for Social Forestry, Research, and Development in Tamil Nadu was engaged to monitor the movement and nesting of the Olive Ridley Sea Turtles in the Chengalpattu and Madurantagam Ranges in Kancheepuram district and the Vedaranyam Range in Nagapattinam district, and their recommendations were shared with the Forest Department.

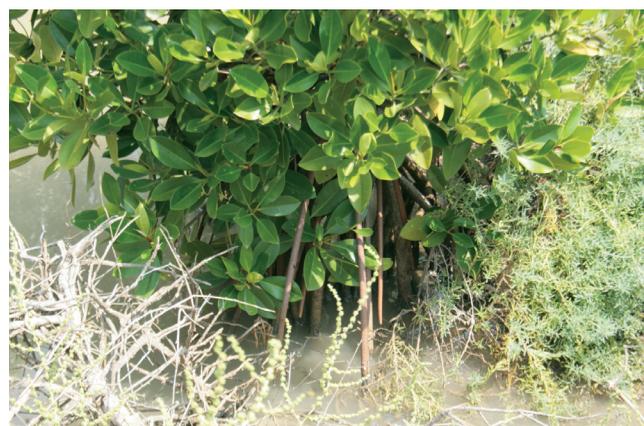
A *Rhizophora mucronata* mangrove tree planted at the junction of the main and feeder canal as part of the ETRP. The *Rhizophora* displays prop roots that not only help anchor the tree but also help the tree breathe. It was reintroduced in Muthupet in 1992 based on studies that confirmed that it was present in this region 150 years back.

Mangrove regeneration was a major component of ETRP. Starting from the main water source, main channels of 2 m top width, 1 m bottom width and 1 m depth were dug out. Feeder channels of 1.5 m top width and 0.75 m bottom width and 0.75 m depth that were connected to the main channel were dug out at intervals of 10 m. This channel network

helps perpetuate the continuous flow of water and keeps the pH values in check, which is necessary for the survival and growth of the mangroves. Mangrove seeds were planted in the soil between October and January on both sides of the main and feeder channels at a spacing of 0.5 m. Seedlings of 10 mangrove species from Pichavaram and Orissa were used. During the first year, channelling and casualty replacement activities were carried out. In the second year, maintenance and de-silting of trenches/channels were implemented. Such adequate protection and care have assured a high rate of success of the mangrove regeneration component of ETRP.
