**Document of the
World Bank**

**Port Access in the Lake Tanganyika:
Key Challenges and Recommendations**

Water Global Practice
Africa Region

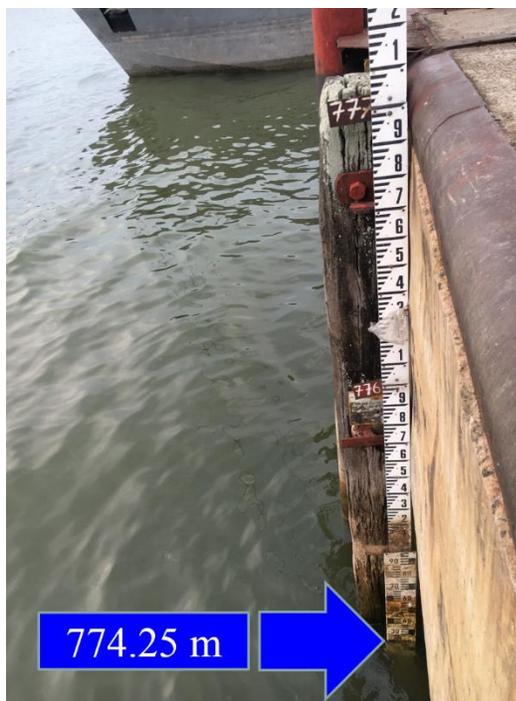
At the time of the visit during the last week of October 2016, the lake level was of 774.25 m a.m.s.l., verified in the scale of the Bujumbura port (Figure 2.1). At that level and after recent dredging, the ports of Bujumbura and Kigoma offer a reported depth of 4 meters, with good operations and no docking problems. Similar depths are reported for the ports of Uvira and Kalemie, but difficult docking conditions are reported for large ships. This is due to narrow access channels, rock outcrops (the cause of shipwrecks) and lack of navigational aides.

Figure 2.1: Lake Tanganyika Level as reported by the scale of the port of Bujumbura (October 24th of 2016).

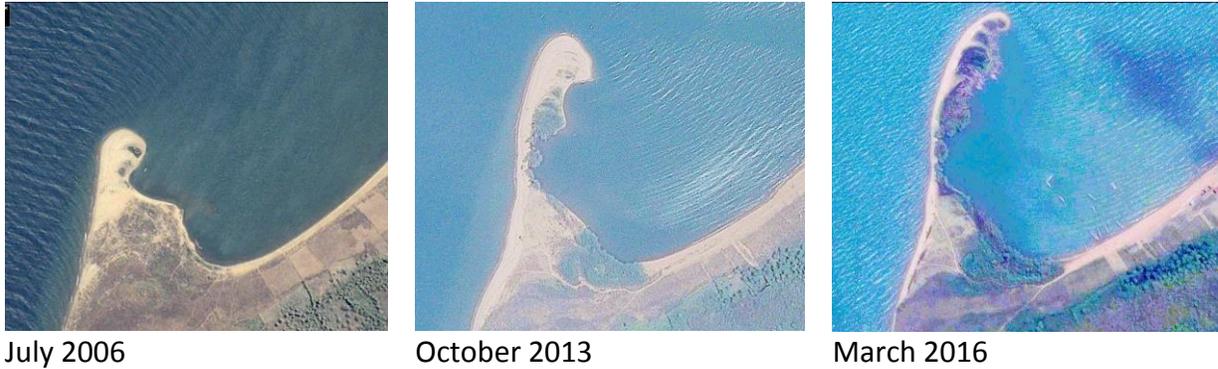
Figure 2.3 shows the 10 year evolution of a sand spit in Burundi’s coast. Although that is not a rapid evolution, it shows that the persistence of the wave action is sufficient for driving the evolution of local features in the shores of Lake Tanganyika.

Figure 2.3 – Evolution of a sand spit at about 22km south of Port of Bujumbura (growth of 150m in 10y)

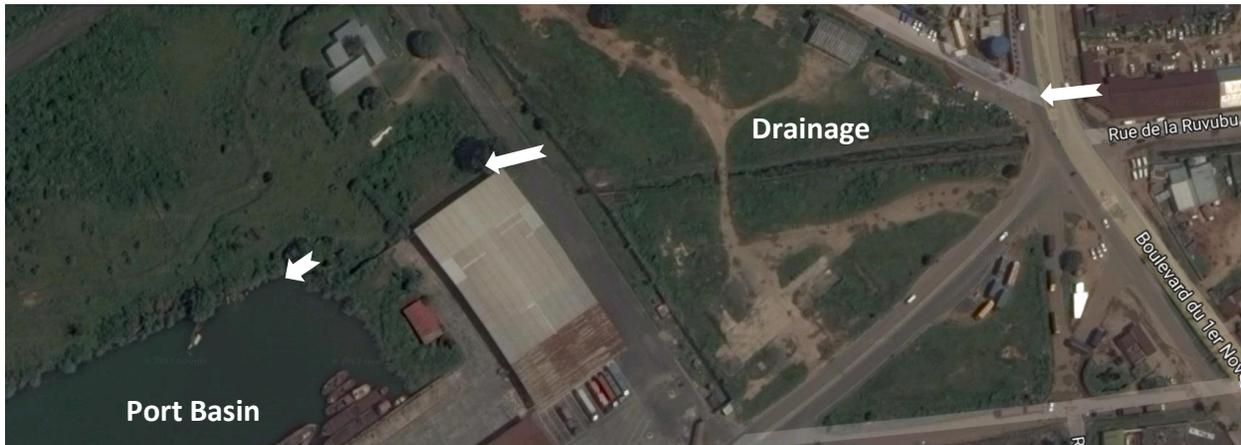
In addition, there is an urban drainage collector coming from the city which drains into the inside of the port basin, bringing sediments directly into the port (Figure 2.5).

Figure 2.5: Aerial view of the urban drainage collector from the city directly draining into the port basin.

Also as a priority, two specific measures need to be taken. First, the course of the urban drainage collector leading directly into the basin of the Bujumbura port (and transporting sediments there) needs to be changed to reach the lake at a different location outside the port. Alternatively, the current path could be maintained, but works would be necessary to prevent the transport of sediments into the port basin (sediment traps or filters), but this option would entail maintenance challenges. Second, the neighboring area to the port of Kalundu (Uvira, DRC) has been reported to be a source of sediments that are drained directly into the port. Works should be done to protect the port basin and access channel from sediment sources in its immediate vicinity.

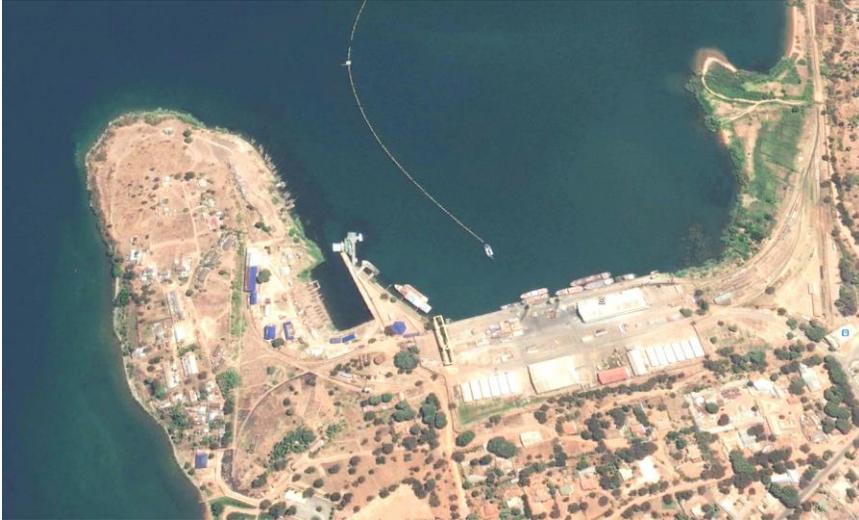
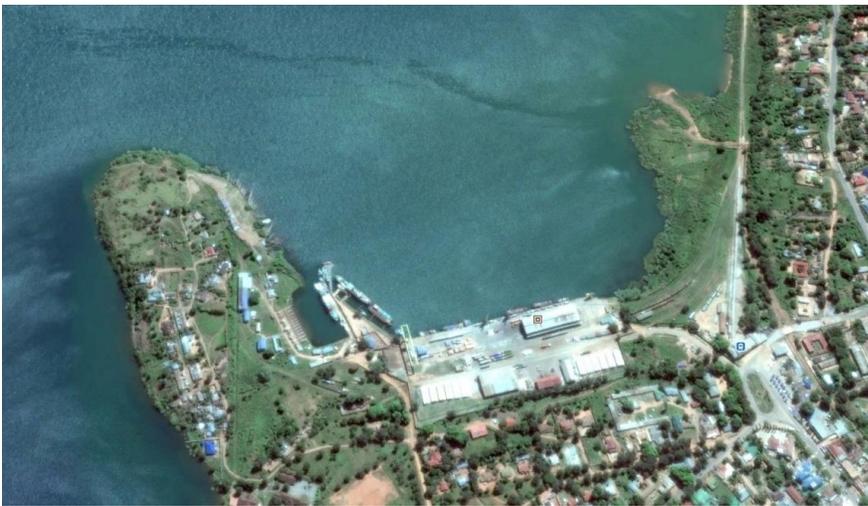
Local reports indicated that the main source of sediments discharged into the port basin, is an area of about 100 hectares, susceptible to erosion during rainfall and runoff. A more detailed analysis of Google Earth images shows that the catchment area of the Kigoma Bay is in the order of 1000 hectares. The sediments eroded from this entire watershed are the likely causes of significant rises in the port's underwater topography, or port bottom, in certain areas. Local measurements in 2010 estimated a sediment fill of approximately 4m since previous or initial port depths (Rutagemwa 2010). As regular or periodic quantitative measurements and surveying capabilities are lacking, the need for bathymetric survey equipment is highlighted, as well as for sediment granulometric analysis. Local knowledge and past dredging statistics may be used in the meantime to estimate sedimentation rates and dredging needs.

Figure 2.6 - Port of Kigoma in 2010 (above) and 2016 (below)

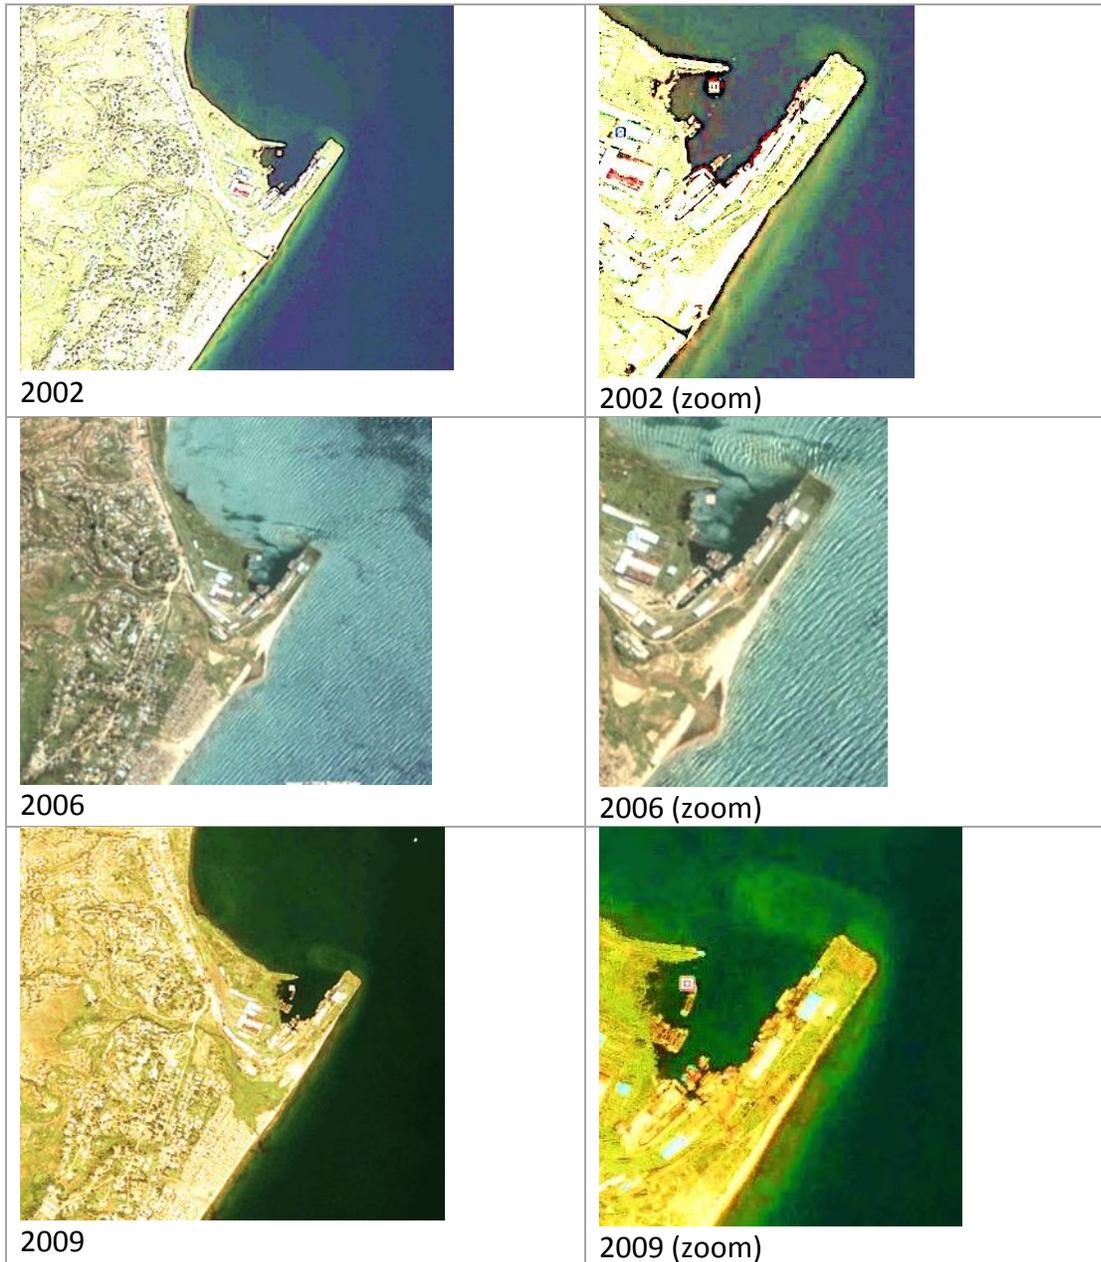
The Kalemie River reaches the Lake just to the south of the Kalemie port, adjoining its facilities and the railroad station. It drains a watershed that over the last decades lost its vegetative cover in a complete transformation from rural to urban, and which is an important source of sediments. Prevailing winds from the Southeast create waves which, when breaking near the shore put sediments in suspension in the water, and yield currents from south to north. The significant contribution of sediments from the Kalemie watershed, and the winds/waves from the South East, make the sediments travel the short distance along the coast and port breakwater, tending to sediment at its entrance. These processes can be seen very well in

Figure 2.7, where in year 2006 one can observe a small delta at the mouth of the Kalemie River, delta that was not there in year 2002. However, in 2009, the delta has been eroded by the wave action and the sediments transported north along the coast, most of which likely settled at the end of the breakwater and entrance of the port, as can be observed in the lower right image of the figure. This is a typical pattern of sedimentation in coastal ports with similar structures, as can also be seen in the port of Kalundu in Uvira.

Figure 2.7 – The port of Kalemie and the adjoining Kalemie River to the south. Note the Kalemie river delta in 2006, its disappearance in 2009, and the accumulation of sediments along the breakwater and entrance of the port.

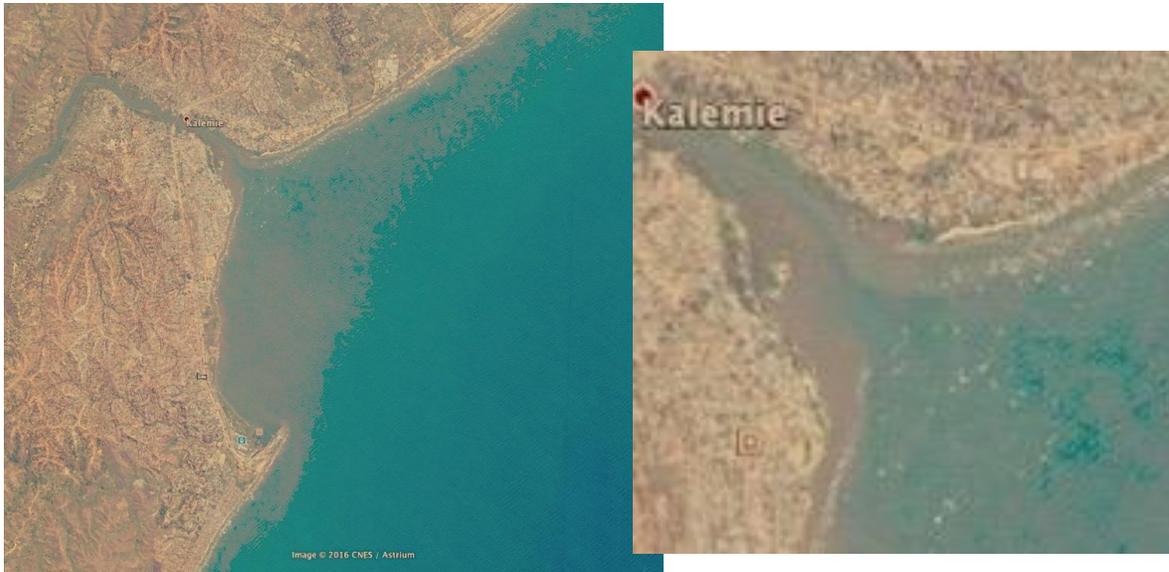
The Port of Kalemie is also located about three kilometres south of the Lukuga River mouth. The flow towards the river may also produce currents in that area of the lake that converge towards its mouth. This can be seen in the paths of fine brown sediments in suspension being transported towards the river (Figure 2.8).

Figure 2.8 – The Port of Kalemie and the mouth of the River Lukuga.

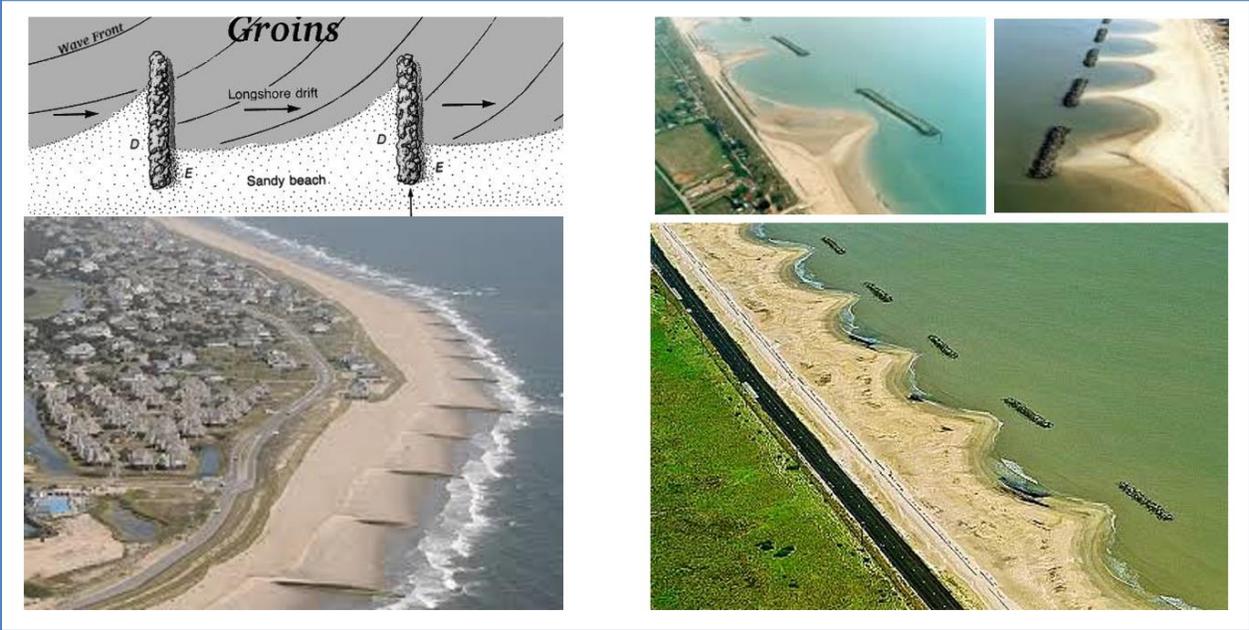
Coastal structures can be helpful in some cases, to significantly reduce the amount of sediments entering the ports and are cheaper to maintain. Periodic removal and emptying of sediments from coastal structures is much easier as it can be done from the land. Structures like groins and breakwaters can accumulate sediments as they travel along the coast, depending on the prevailing wind and wave direction (Figure 4.1). A hypothetical groin field south of the port of Kalemie is represented in Figure 4.2 between the mouth of the Kalemie River and the Port of Kalemie, to display how sediments could be captured and periodically

Figure 4.1: Illustration of groins (left) and breakwaters (right) as structures to retain sediments along the coast.

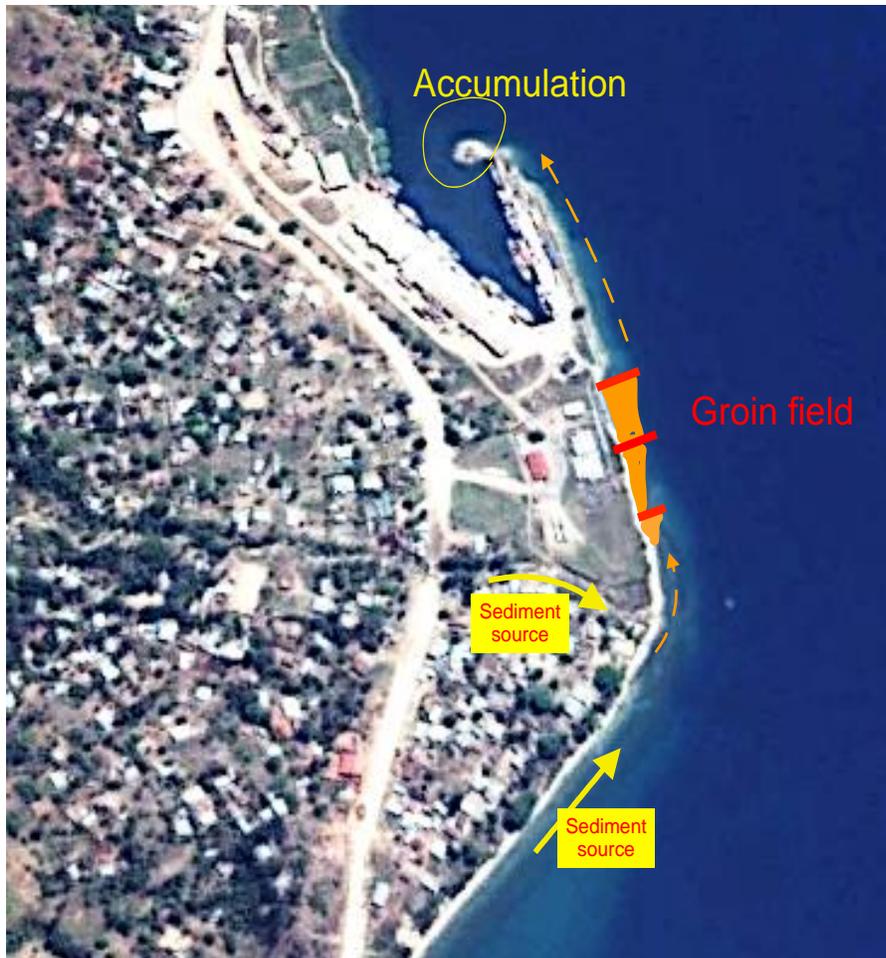
Figure 4.2: Illustration of how a hypothetical groin field in the shores of Kalemie can capture sediments from the Kalemie River and traveling along the coast, to prevent their accumulation at the entrance of Kalemie's port.

removed before they travel to the port and settle at its entrance. The periodic removal of sediments from the coastal structures would best be done during the low water levels at the end of the dry season.
